# MONITORING REPORT

## REYNISFJARA BEACH

Report for measurements done on  
15<sup>th</sup> of June 2026 by

**Colorado Academy**

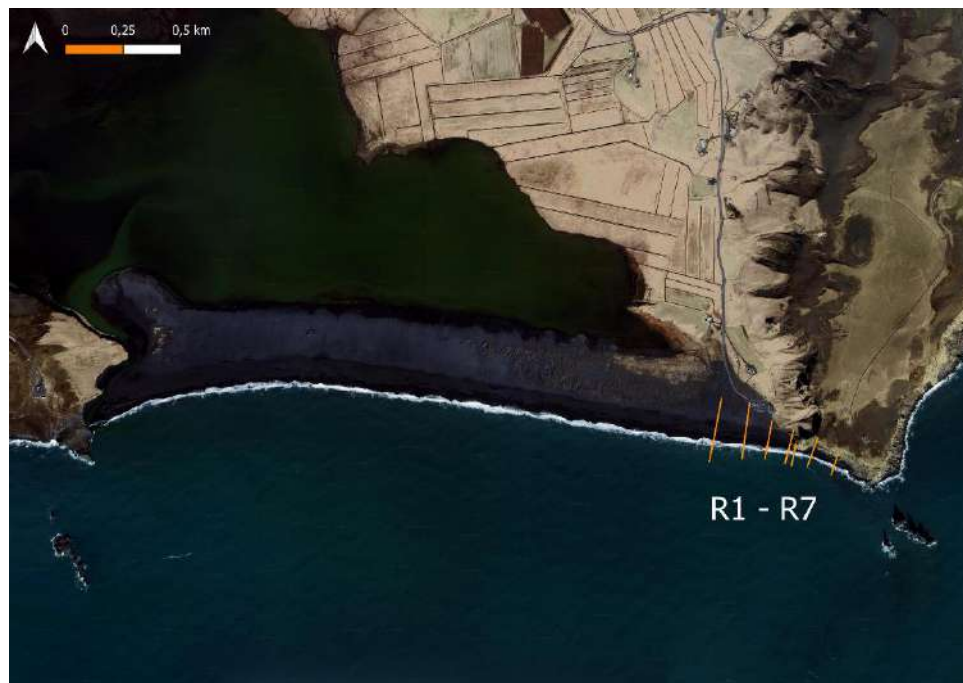
Figure 1 shows the extent of Reynisfjara beach, along with the seven profiles on the eastern side of the beach, Dyrhólaey promontory, Dyrhólaós estuary, and Reynisfjall mountain.

The objective of the monitoring program for Reynisfjara beach is to document the morphological and environmental changes at Reynisfjara beach. Seven profiles are on the eastern part of the beach (figure 1 and 2) which monitor any changes to the beach width and volume. The profiles are measured monthly during spring tide. The profiles are measured by using GTS-6 TopCon XR GPS devices with accuracy of about  $\pm 1$  cm. Along with measuring the beach profiles, photos and drone photos are taken of the beach itself and the environment behind it.

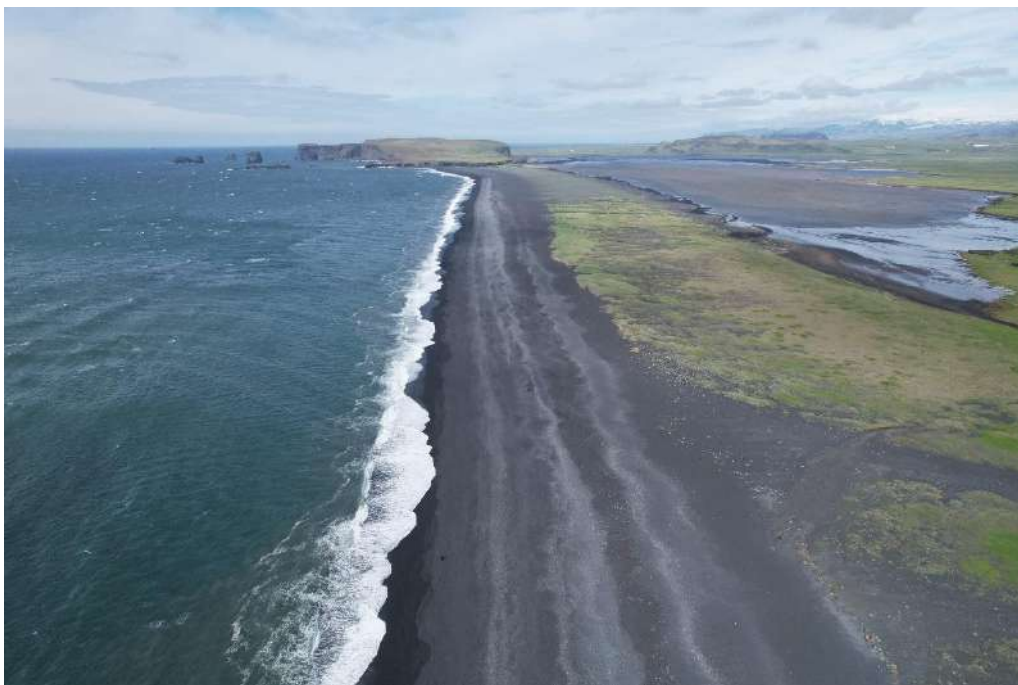
*Figure 8 shows the central and western part of Reynisfjara beach, with Dyrhólaey promontory in the distance.*

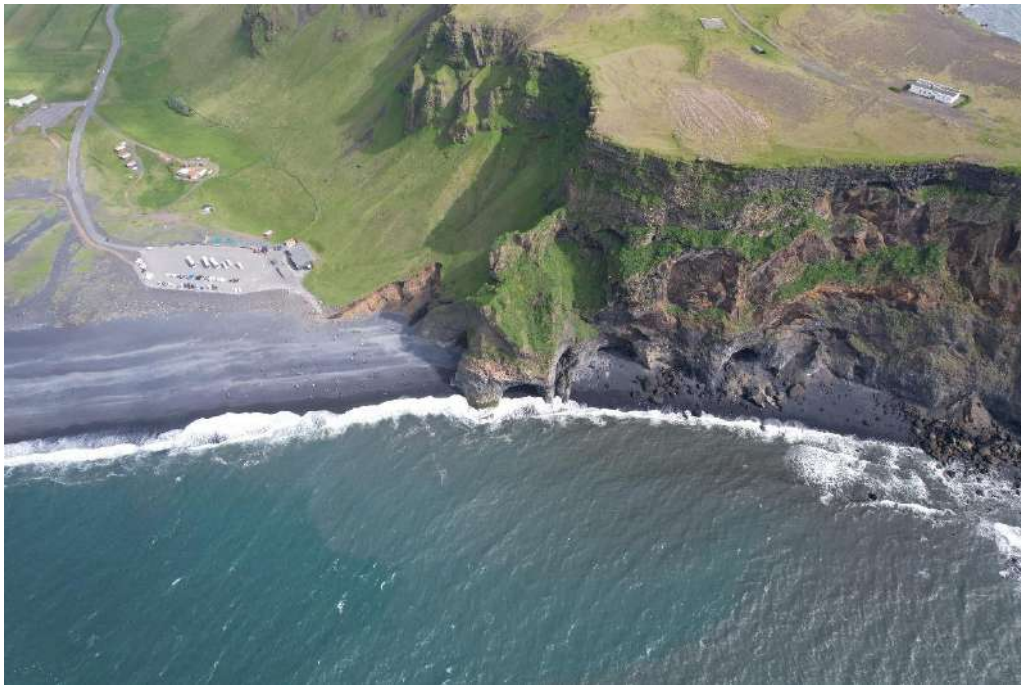
*Figure 9 shows the cliff face of Reynisfjall at 10:37 on the 15<sup>th</sup> of June. There is no fresh rock deposit on the beach at that moment.*

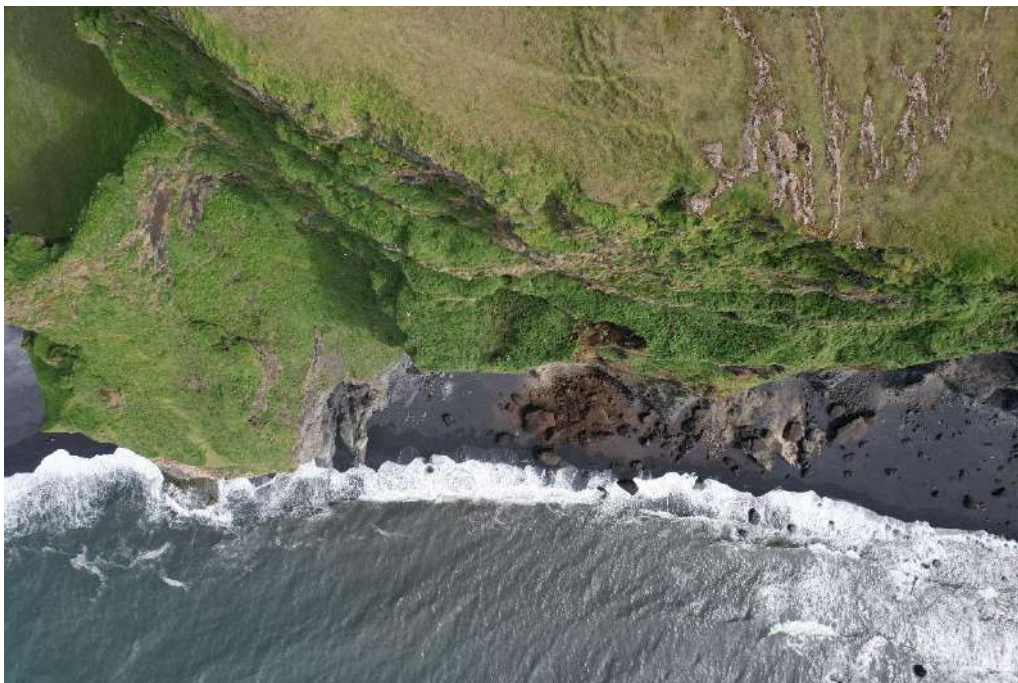
overhanging rock. It is therefore likely that there will be several rock collapses in the coming years. At least three collapses have already happened in 2026 and one of them happened during the measurement of the beach on the 15<sup>th</sup> of June. That collapse happened between 10:37 and 10:55 on the 15<sup>th</sup> of June, as a drone photo that was taken at 10:37 (figure 9) shows no fresh debris on the beach, while a drone photo taken at 10:55 (figure 10) shows fresh debris on the beach and a small scar on the cliff face. The exact size of the collapse is not known, but it was not very large (figure 11) and seems to consist mostly out of smaller rocks and soil. Since then, however, there has been more collapse from the same ledge on the cliff face, and the entire ledge has collapsed. This collapse was much bigger (figure 12) and it was fortunate that that part of the beach has been inaccessible as the collapse would have

*Figure 10 shows the cliff face of Reynisfjall and the beach below. The photograph was taken at 10:55 on 15<sup>th</sup> of June. There is fresh debris on the beach and a new scar in the cliff can be seen as well.*

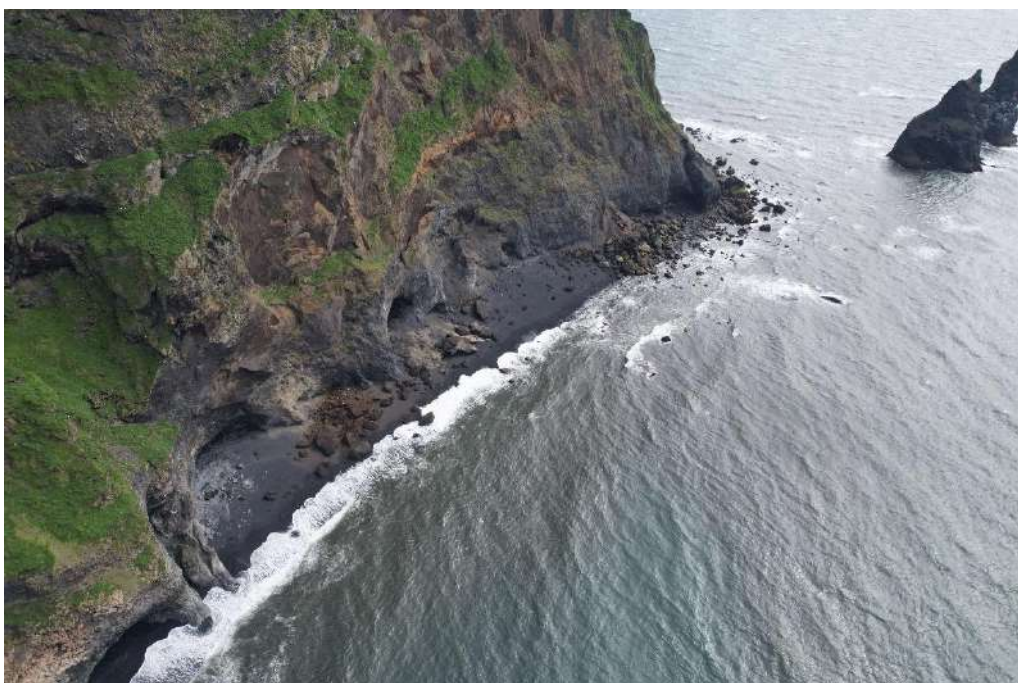
*Figure 11 shows the cliff face of Reynisfjall at 11:11 on the 15<sup>th</sup> of June. Fresh debris can be seen on the rocks on the left and the scar on the cliff can be seen as well.*

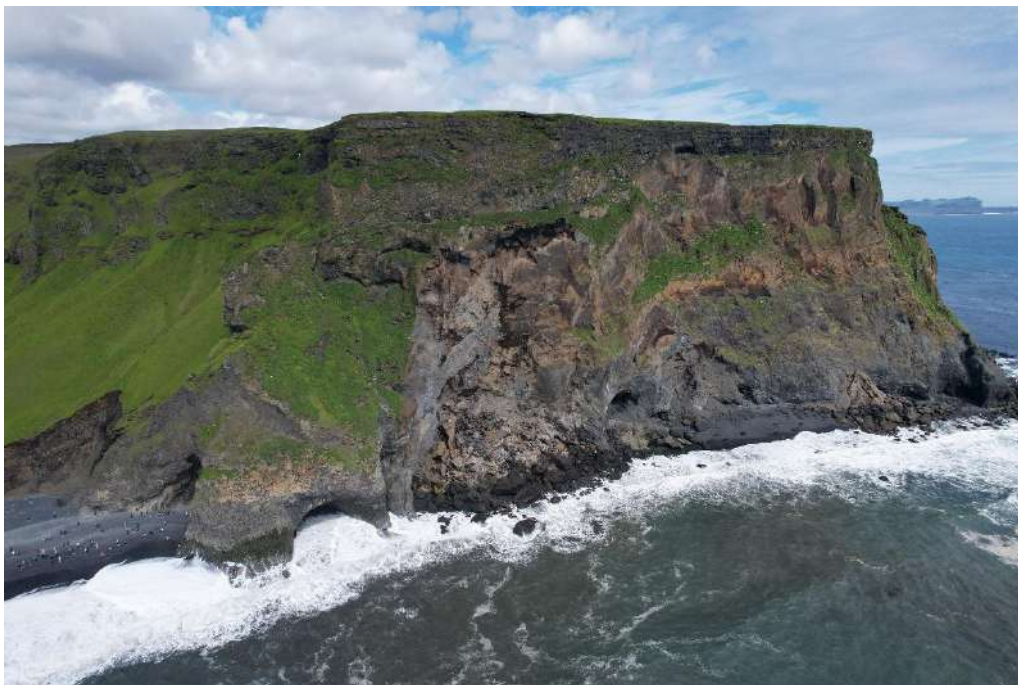
Figure 12 shows the new rock collapse from Reynisfjall mountain. The photo was taken on the 3<sup>rd</sup> of July 2026.

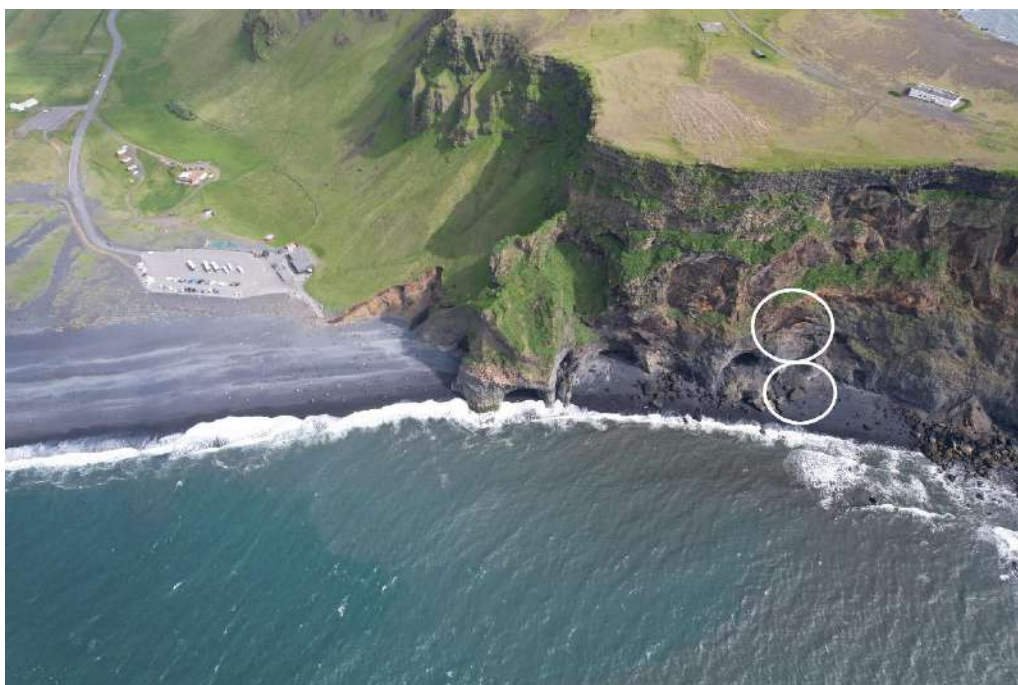
An older rock collapse was also discovered using the drone photos that were taken on the 15<sup>th</sup> of June (figures 13 and 14). A small ledge broke off from the middle of the cliff at Reynisfjall. The timing of this collapse is not known but occurred at some point between 11<sup>th</sup> of February and 15<sup>th</sup> of June.

Figure 13 is a photo taken on the 15<sup>th</sup> of June, where the ledge (upper white circle) has broken off from the cliff and there are three large rocks on the beach below (lower white circle).

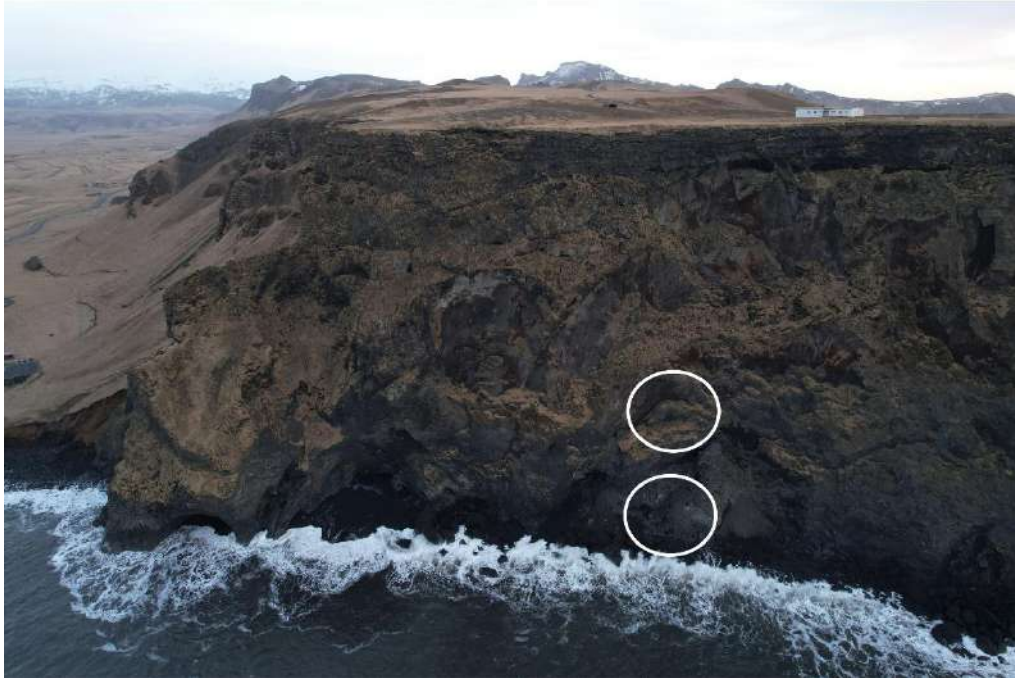
Figure 14 is a drone photo that was taken on the 11<sup>th</sup> of February, where the ledge (upper white circle) is still attached to the cliff and there are no large rocks on the beach below (lower white circle).
