# MONITORING REPORT

## REYNISFJARA BEACH

Report for measurements done on  
24<sup>th</sup> of July 2026 by

**The Molinelli family**

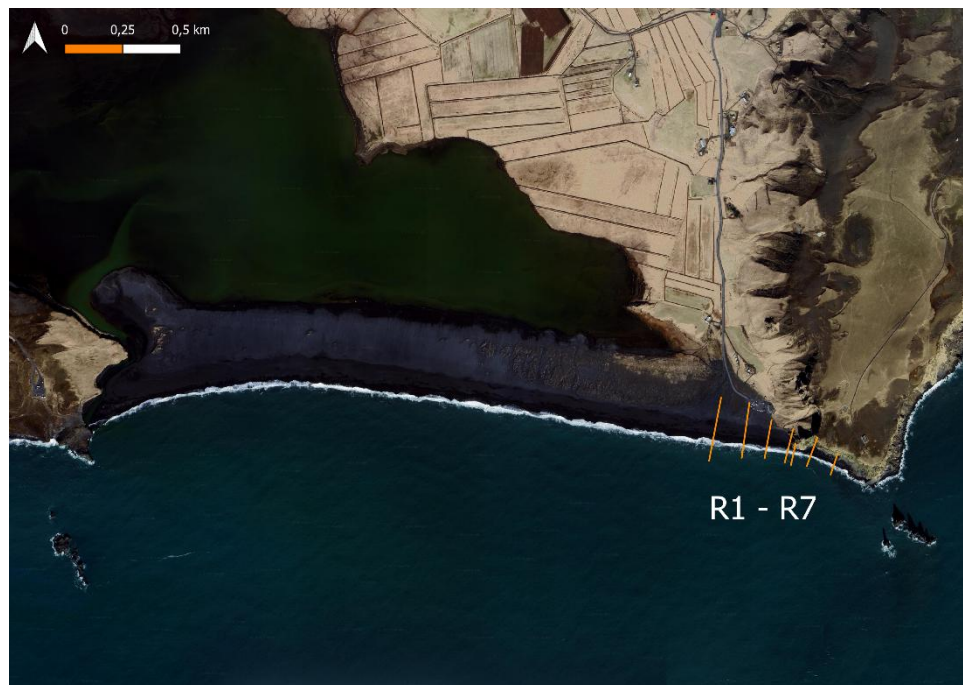
Figure 1 shows the extent of Reynisfjara beach, along with the seven profiles on the eastern side of the beach, Dyrhólaey promontory, Dyrhólaós estuary, and Reynisfjall mountain.

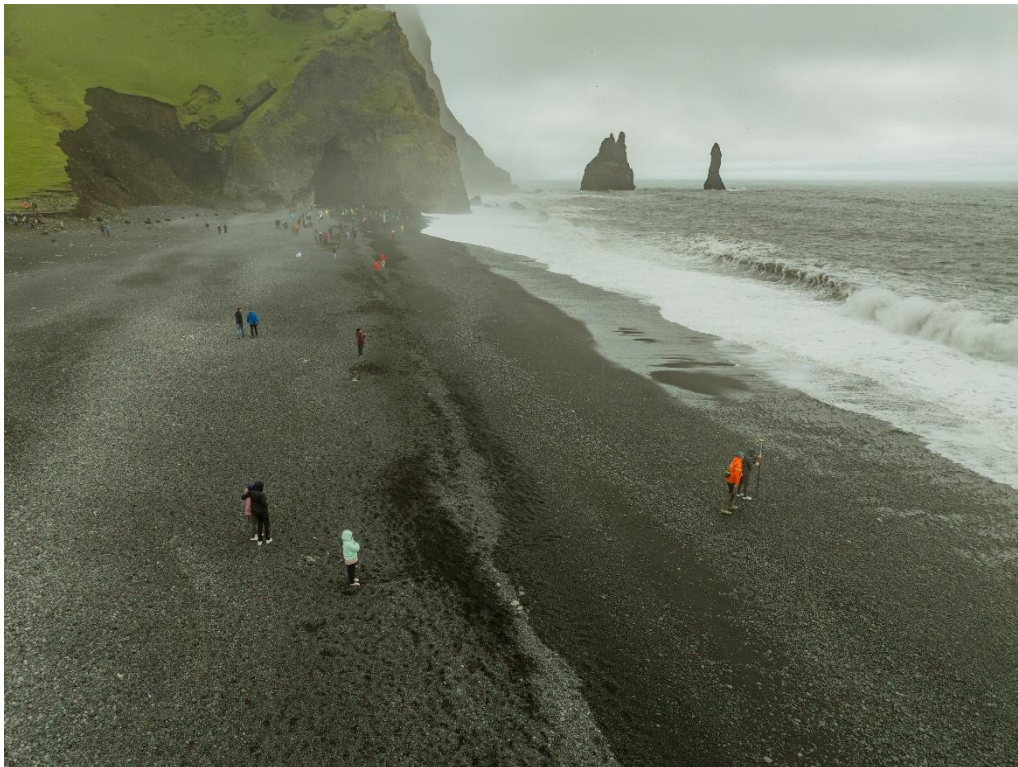
*Figure 8 shows the eastern part of Reynisfjara beach, along with the erosional scarp in Reynisfjall mountain that formed in the erosion earlier in 2026. In the center of the photo, there is a steep gravel ridge and below it is a gently sloping beach face. During the measurement in June, there were two gravel ridges on the beach, but the lower ridge has been fused now with the upper ridge.*

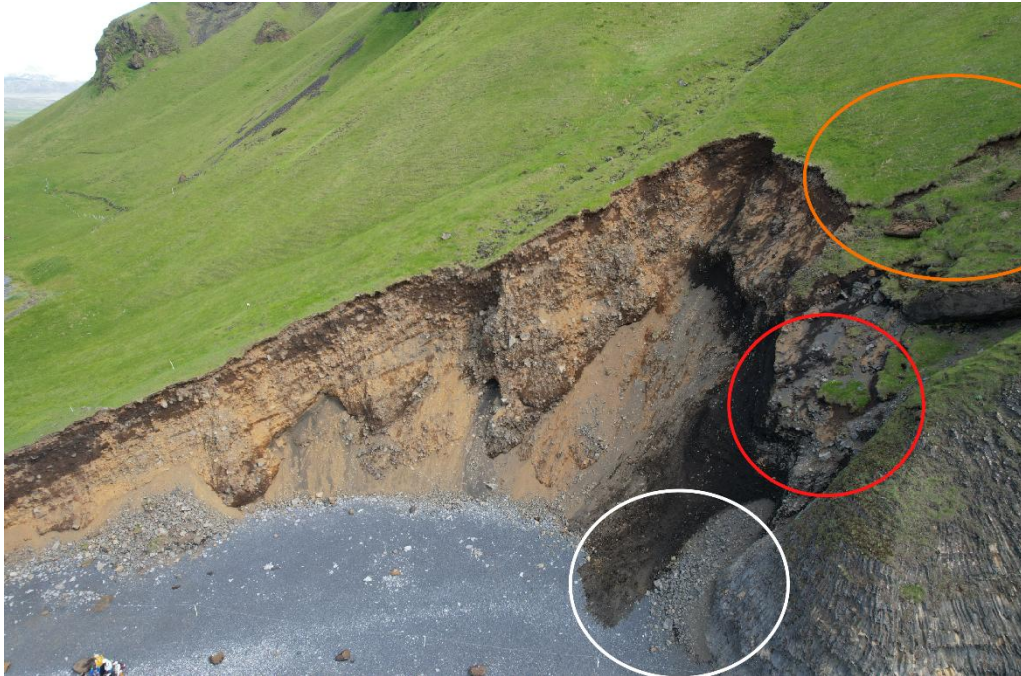
Figure 9 the erosional scarp in Reynisfjall mountain. The red ring shows the active part of the scarp and the white circle is where the material ends up. An old scarp that until now has remained stable and is marked with an orange circle.

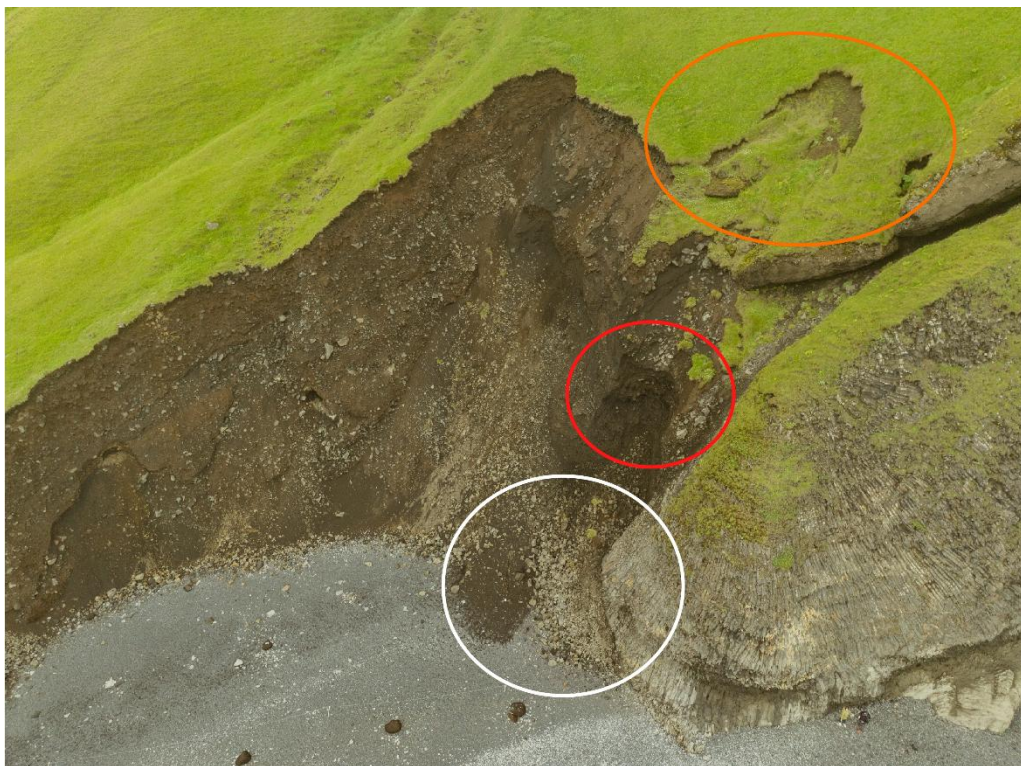
Figure 10 the erosional scarp in Reynisfjall mountain. The red ring shows the active part of the scarp and the white circle is where the material ends up. An old scarp that until now has remained stable and is marked with an orange circle.

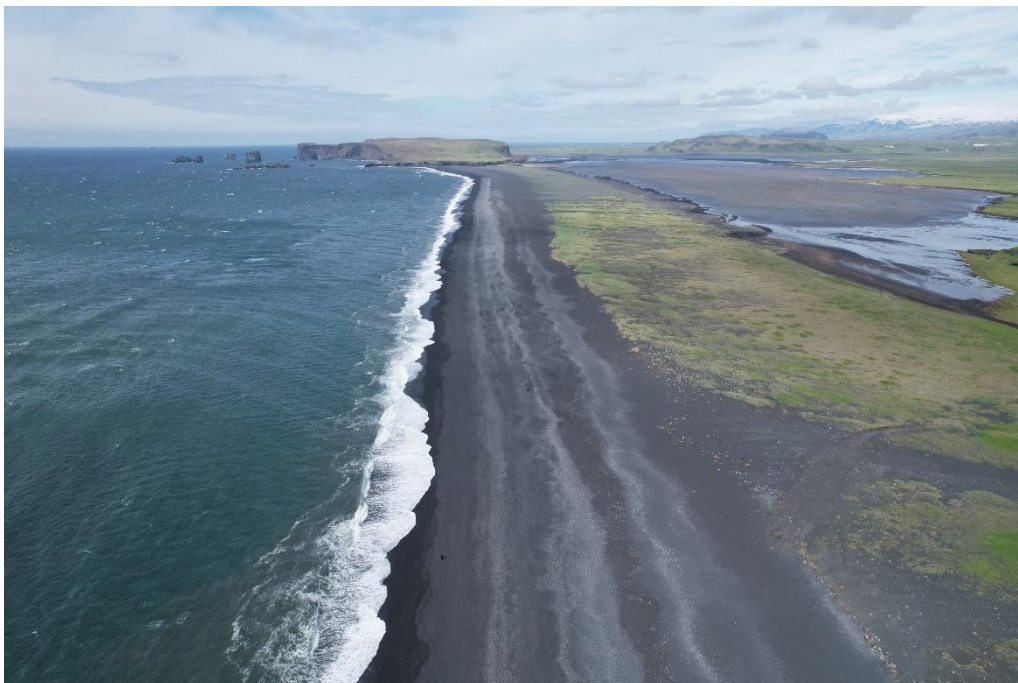
*Figure 11 is from the measurement in June and shows the central and western part of Reynisfjara beach, with Dyrhólaey promontory in the distance.*

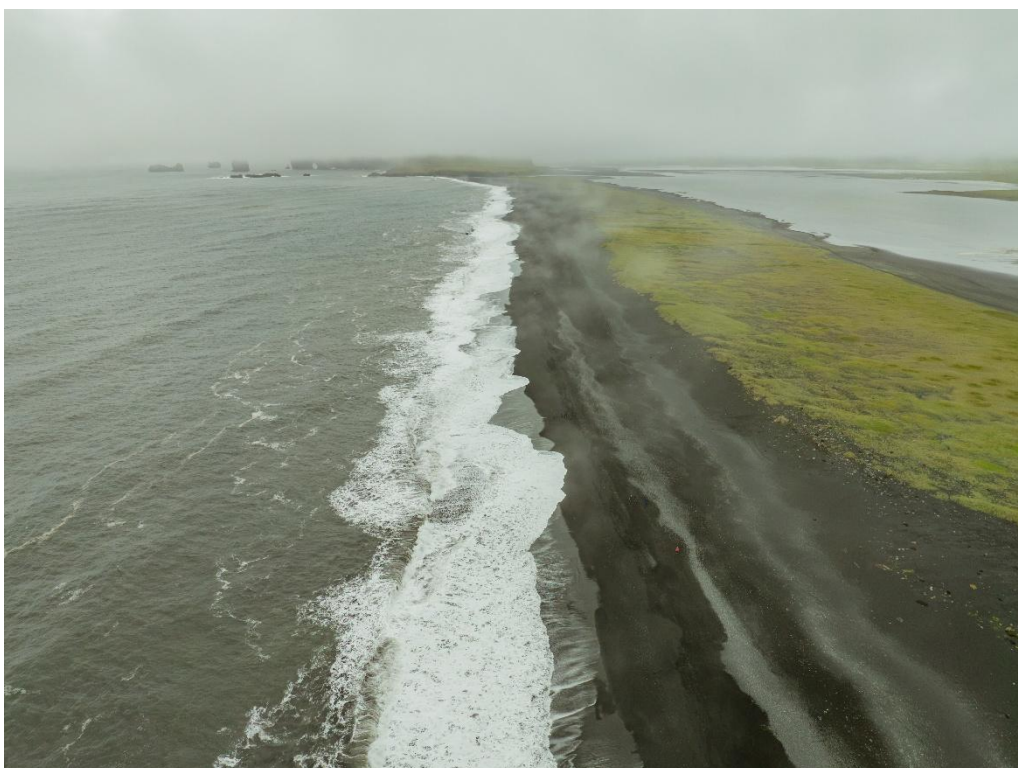
changes to the upper part of the beach between measurements. On the lower part of the beach, the lower gravel ridge that was present in June (thin grey line close to the waterline on figure 10) is no longer present on figure 11, as it has been welded on to the higher ridge. Due to high water level and waves, the lower part of the beach face was not accessible during the measurement in July.

*Figure 12 is from the measurement in July and shows the central and western part of Reynisfjara beach, with Dyrhólaey promontory in the distance.*

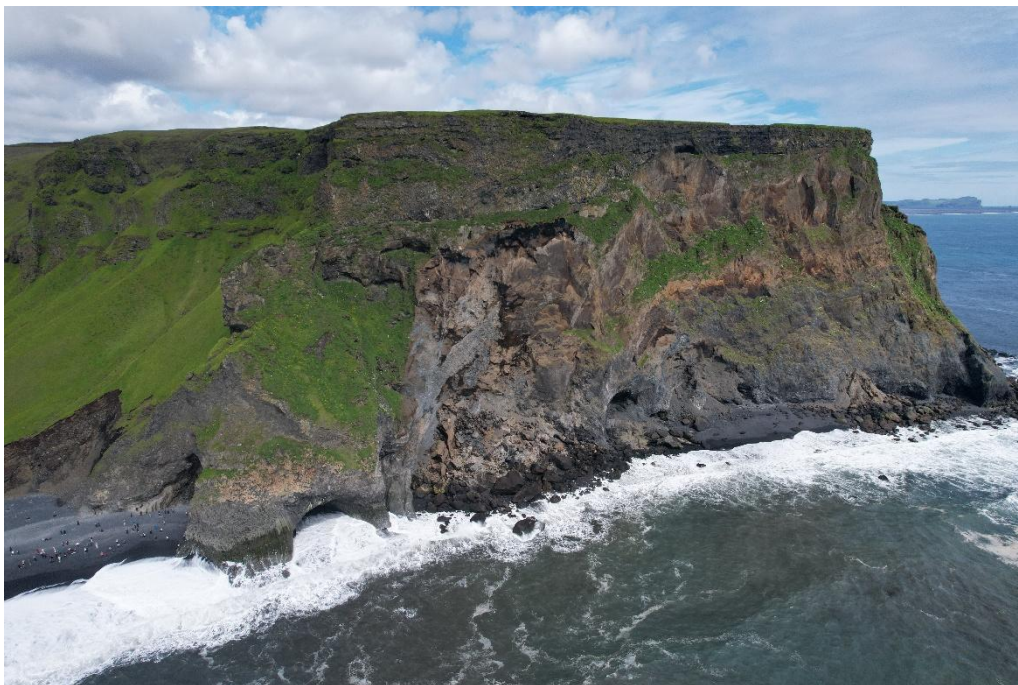
*Figure 13 shows the new rock collapse from Reynisfjall mountain. The photo was taken on the 3<sup>rd</sup> of July 2026.*

One of the objectives of the monitoring at Reynisfjara beach is to observe the slope stability of the cliff face of Reynisfjall mountain. There have been several rock collapses from the mountain in the last few decades, and the most recent one was in 2019 (MBL, 2019). These collapses occur due to wave undercutting of the cliff of Reynisfjall during severe storms, and erosional events like occurred earlier in 2026, which weaken the stability of the overhanging rock. It is therefore likely that there will be several rock collapses in the coming years. At least three collapses have already happened in 2026, and the most recent one can be seen on figure 12 that was taken on the 3<sup>rd</sup> of July. Figure 13, which was taken during the measurement, does not show any fresh collapses on the beach, but the material from the collapse in June is being reworked by waves.

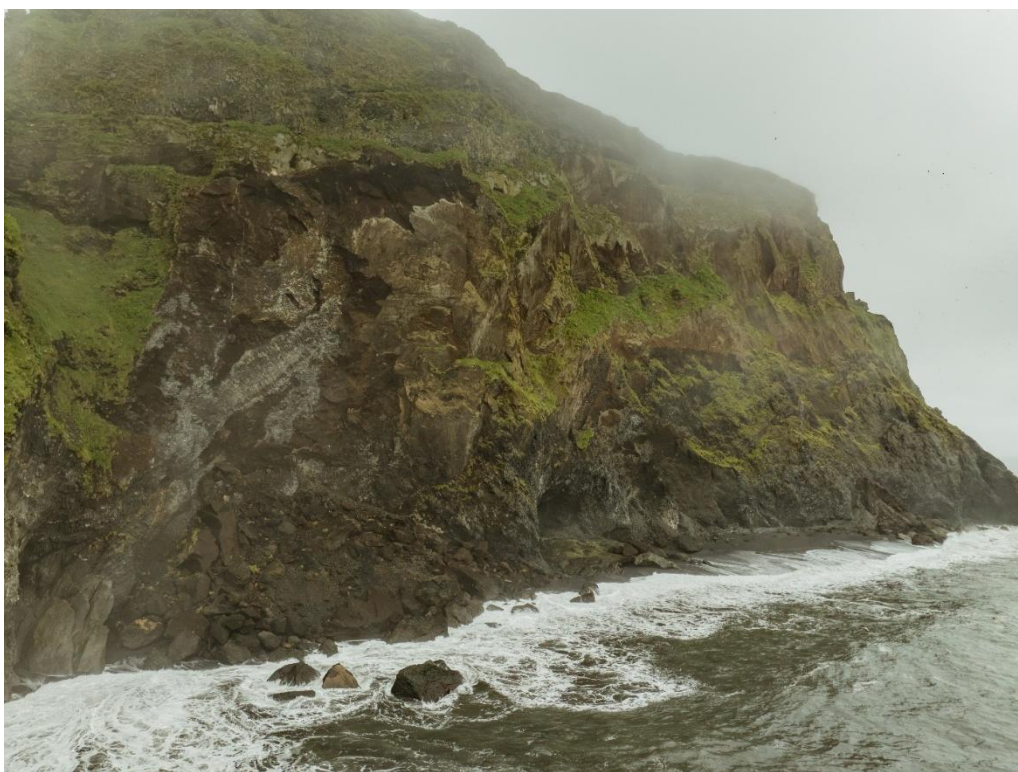
*Figure 14 shows the beach below the cliff face of Reynisfjall. No new collapses seem to have occurred since 3<sup>rd</sup> of July, but the material from the collapse in June is being reworked by waves.*
